HomePro Home Inspections  
PO Box 6261  
Rochester, MN 55903

1234 Any Place SW  
Some Town, MN 0U812

## Maintenance Summary

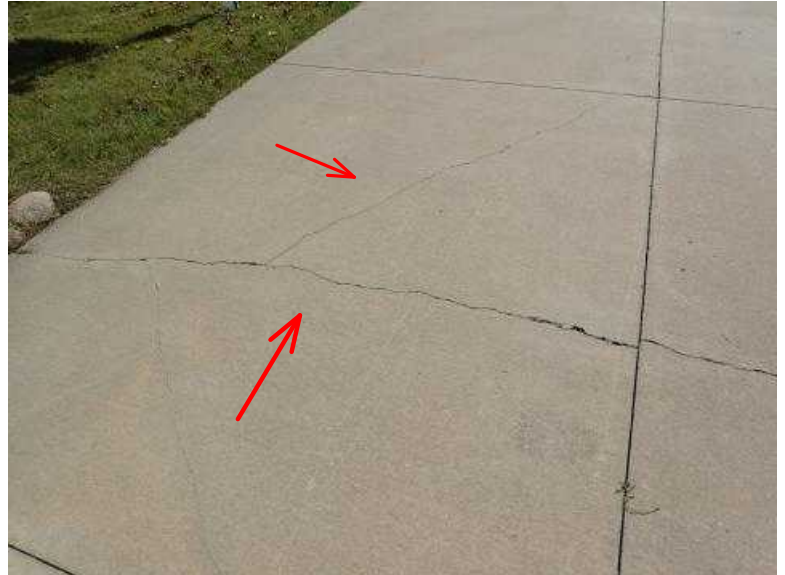
Driveway: Concrete,  
Common cracks -  
Recommend sealing cracks  
in driveway

1. Driveway: Concrete, Common cracks - [Recommend sealing cracks in driveway](#)

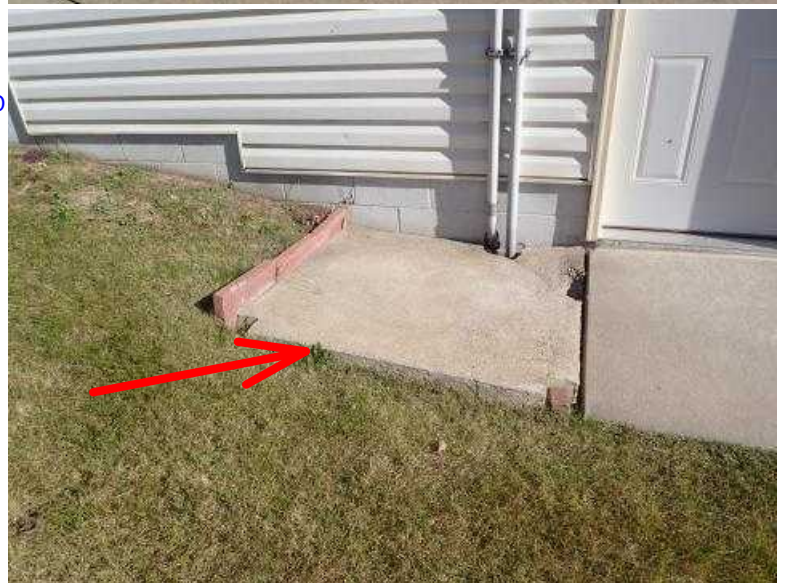
Sidewalks: Concrete,  
Common cracks - Surface  
raised or settled, creates trip  
hazard

1. Sidewalks: Concrete, Common cracks - [Surface raised or settled, creates trip hazard](#)

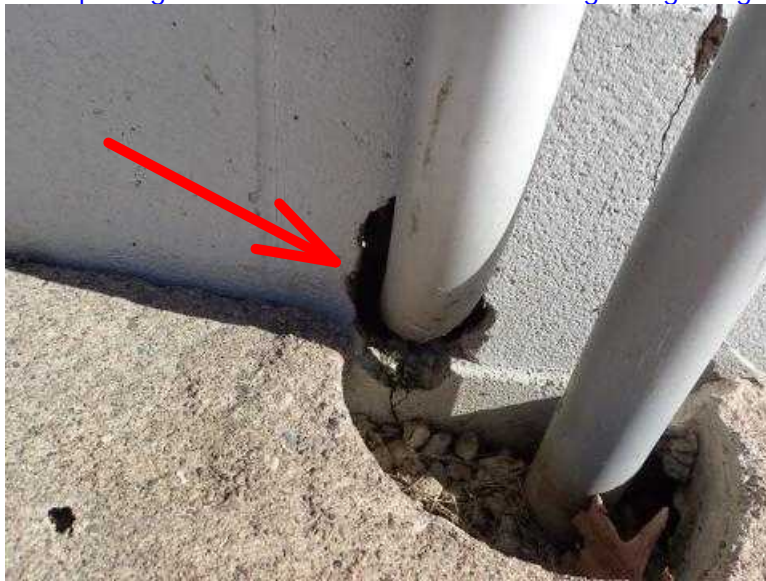
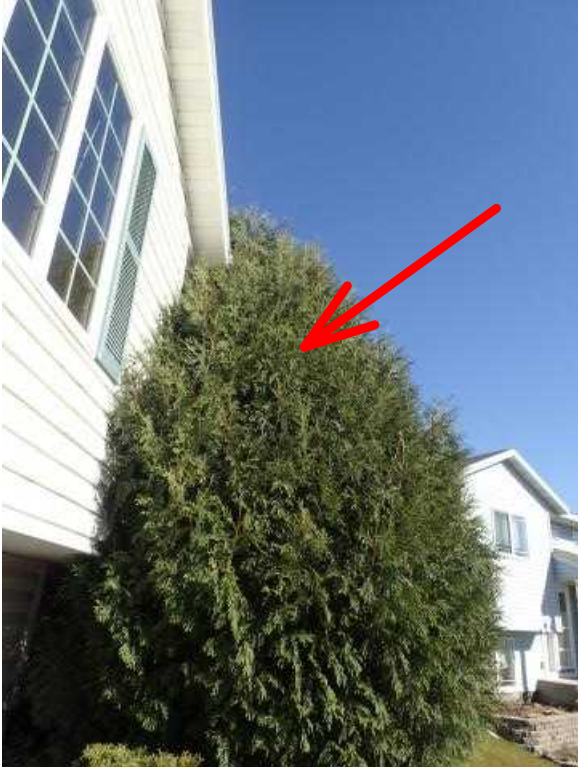
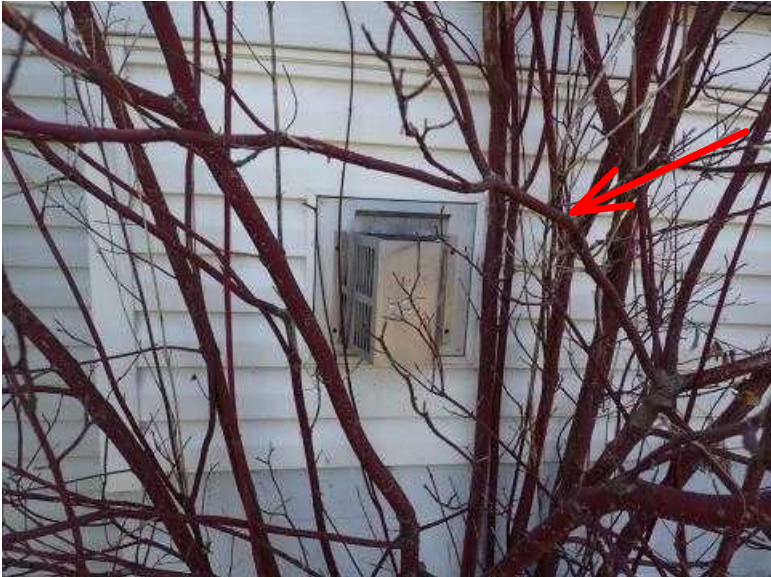
1. Repairs Recommended Exterior Walls: Wood frame, Vinyl siding, Common cracks - [Recommend sealing cracks and openings at exterior. Recommend cutting foliage/vegetation away from siding](#)

2. Exterior Walls: Wood frame, Vinyl siding, Common cracks - [Recommend sealing cracks and openings at exterior. Recommend cutting foliage/vegetation away from siding](#)
3. Gutters/Downspouts: Fully installed - [Downspout missing at rear garage](#)

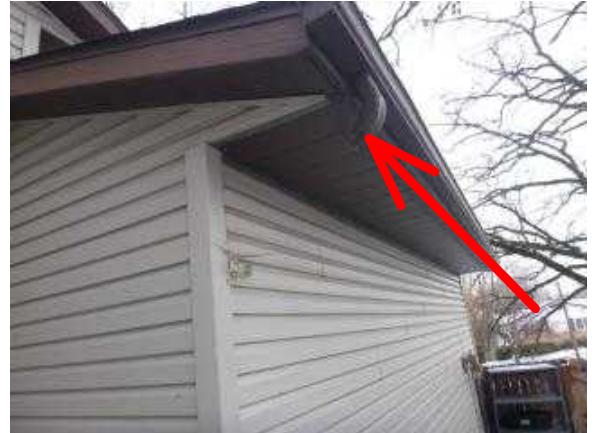
- 2. Acceptable Trim, Soffit, Eaves: Wood, Metal, Common cracks
- 3. Acceptable Hose Faucets: Anti frost
- 4. Repairs Recommended Gutters/Downspouts: Fully installed -  
[Downspout missing at rear garage](#)

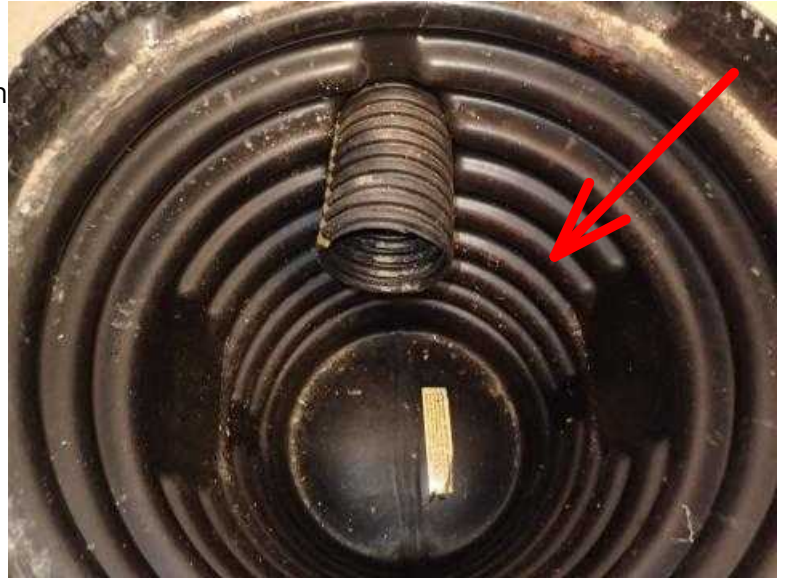
6. Acceptable                      Sump Pump: Sump basket present - pump not present  
- Note - No water present in sump basket

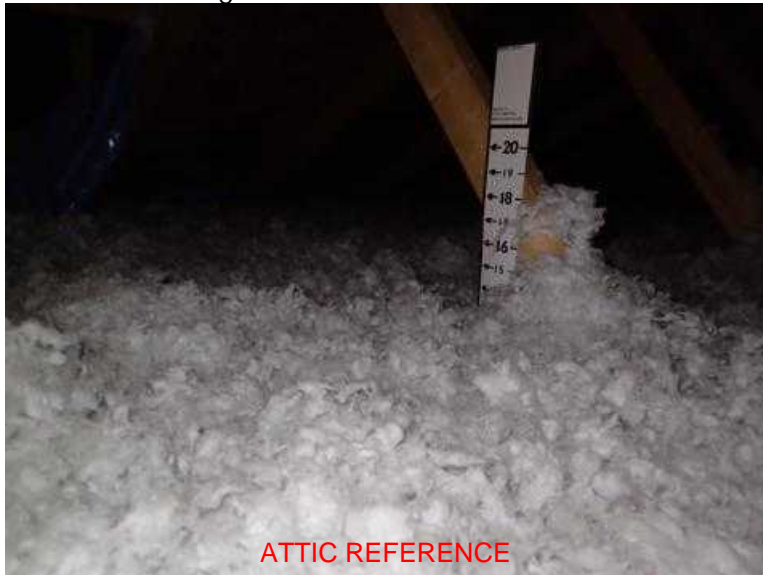
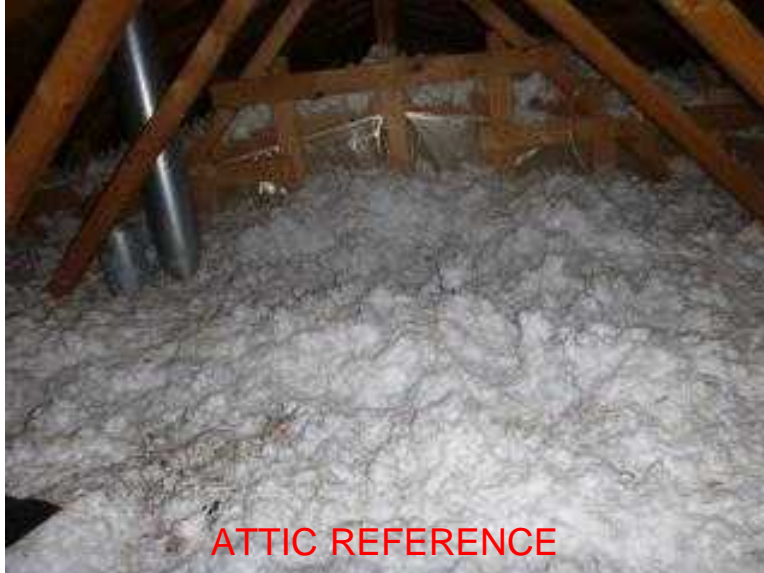
1. Method of Inspection: Inspection limited to view from access
2. Acceptable      Roof Framing: Truss
3. Acceptable      Sheathing: Strand board
4. Acceptable      Ventilation: Roof and soffit vents
5. Acceptable      Insulation: Fiberglass blown - ~ 12 to 14 inches

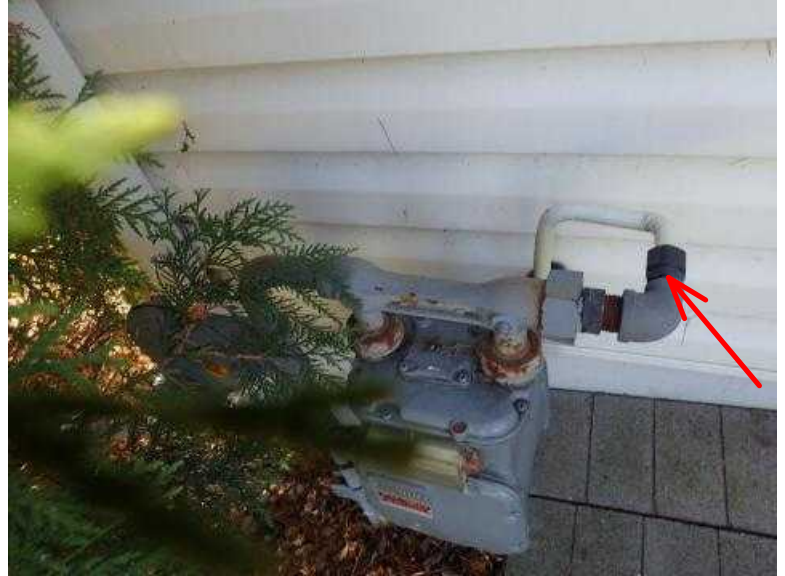
6. Repairs Recommended Gas Meter: Right side -  
Recommend properly bonding CSST gas line

4. Gas Meter: Right side - [Recommend properly bonding CSST gas line](#)
5. Gas Service Lines: CSST - [Recommend providing proper clearance/insulation from adjacent metal surfaces at furnace](#)
6. Basement Water Heater TPRV and Drain Tube: [Inadequate clearance at furnace ducting](#)

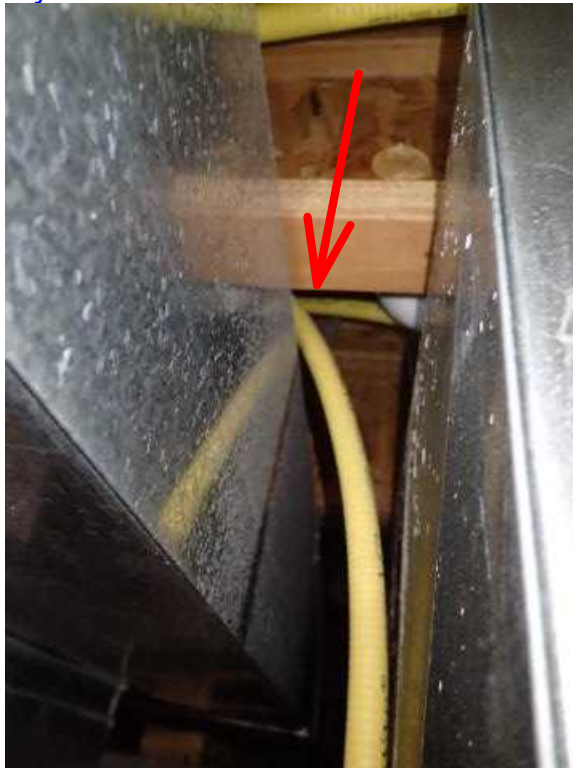
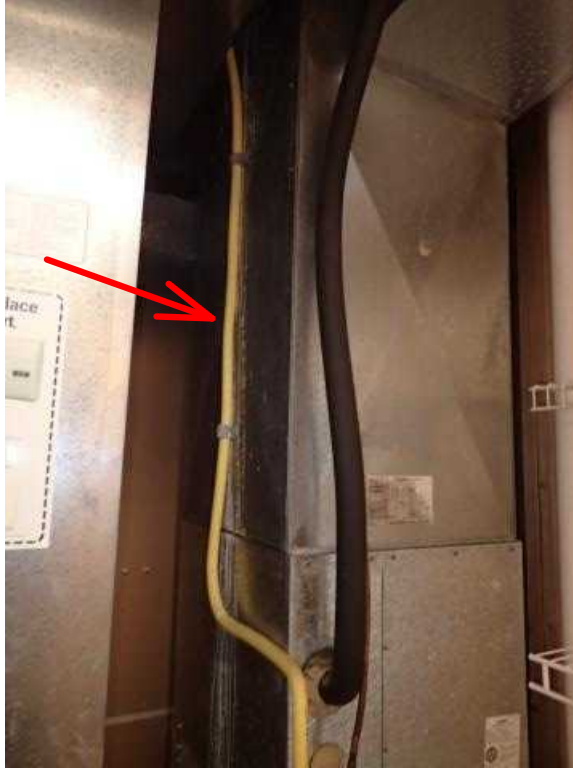
7. Acceptable Main Gas Valve: Located at utility room  
8. Repairs Recommended Gas Service Lines: CSST - Recommend providing proper clearance/insulation from adjacent metal surfaces at furnace

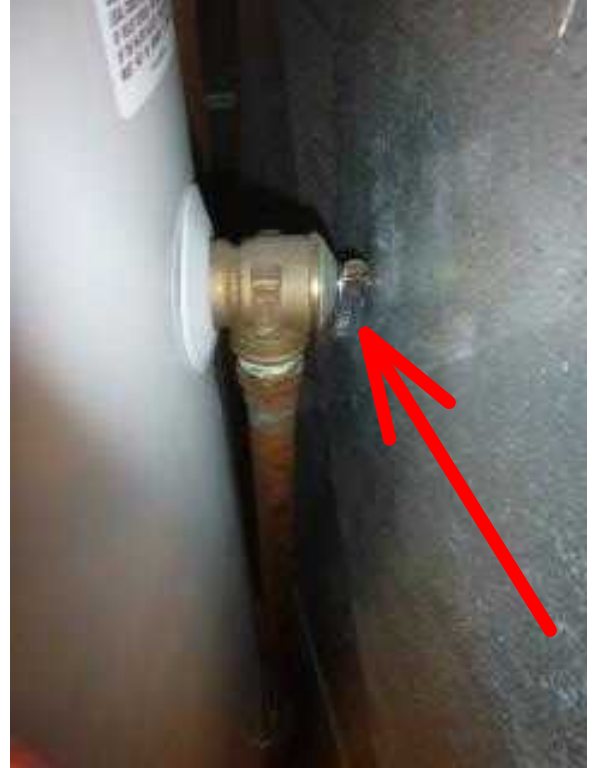
14. Repairs Recommended TPRV and Drain Tube: [Inadequate clearance at furnace ducting](#)

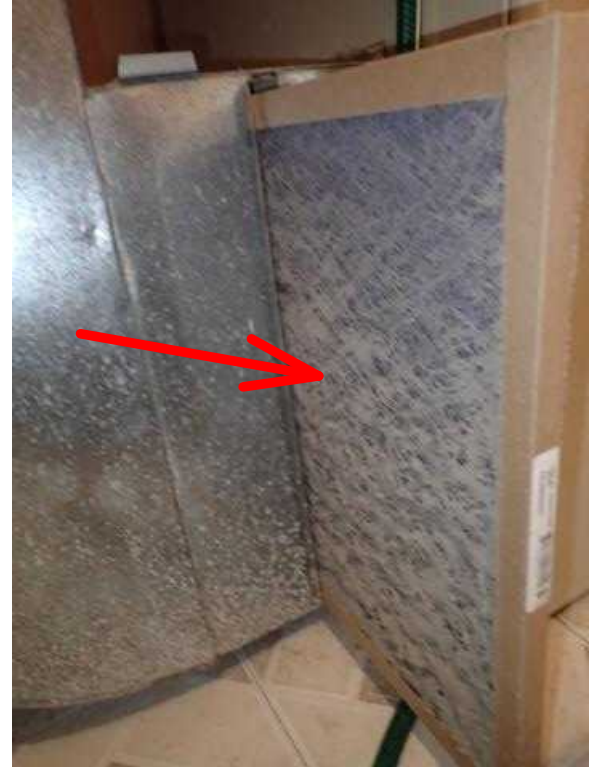
Vent System: Wall direct vent - PVC  
Air Filter: Standard filter - **Filter is dirty** -  
**Filter size - 20x22.25x1**

2. Basement Heating System Air Filter: Standard filter - [Filter is dirty - Filter size - 20x22.25x1](#)
3. Basement Heating System Humidifier: [Recommend replacing filter. System does not appear to have been serviced per manufacturers instructions in past year](#)

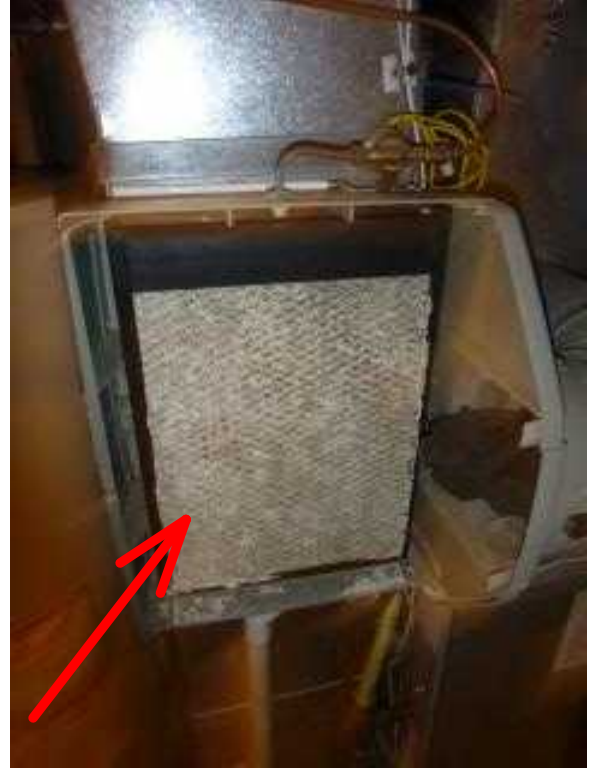
Humidifier: Recommend replacing filter. System does not appear to have been serviced per manufacturers instructions in past year

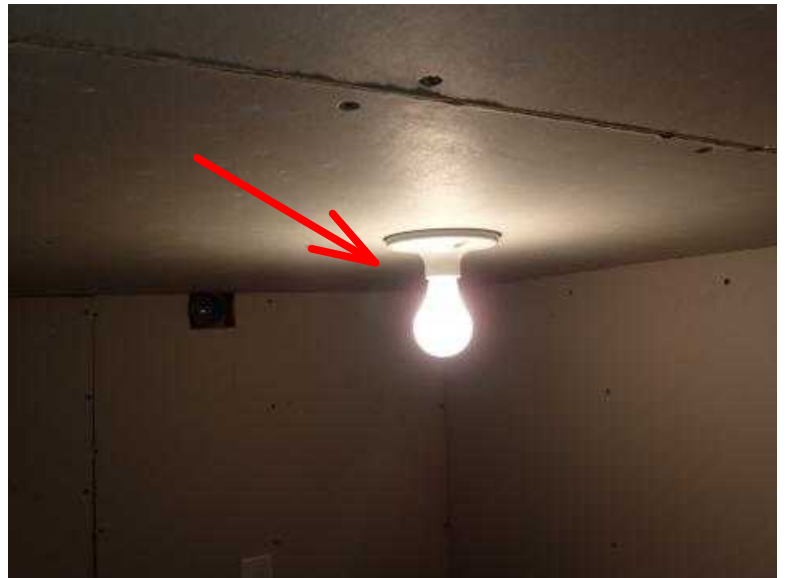
| 6. Repairs Recommended | Wiring Notes: <a href="#">Recommend installing a protective cover onto light at under stairs storage area to prevent accidental bulb breakage</a> |

7. Wiring Notes: [Recommend installing a protective cover onto light at under stairs storage area to prevent accidental bulb breakage](#)
8. Basement Electric Panel Amperage: 150 Amps - [Conduit strap is broken at exterior service panel, Conduit is not secure at exterior service panel, damaged/missing connector](#)

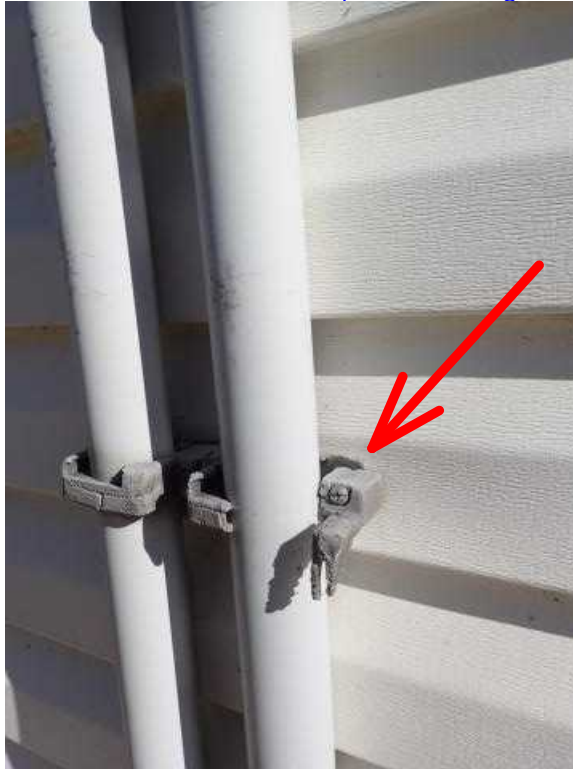
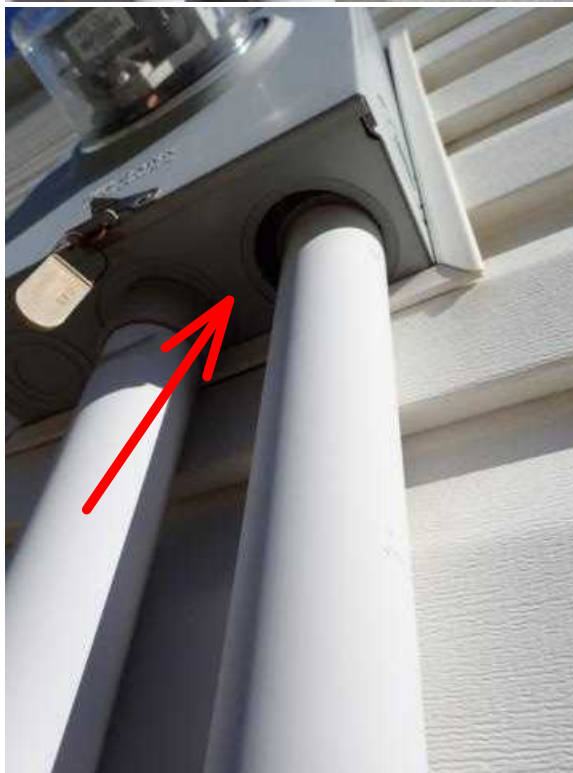
8. Repairs Recommended Amperage: 150 Amps - Conduit strap is broken at exterior service panel, Conduit is not secure at exterior service panel, damaged/missing connector

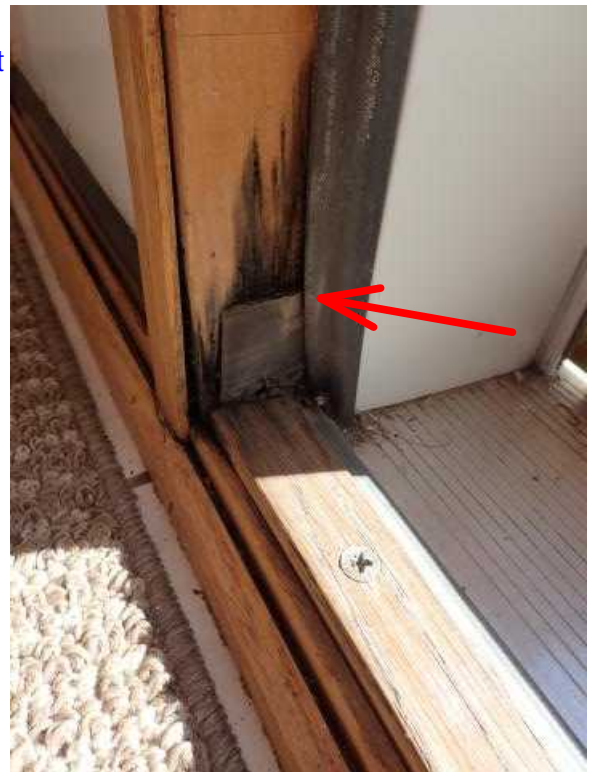
- 1. Repairs Recommended Entry/Exterior Doors Entry/Exterior door hardware acceptable - [Moisture damage at front entry door frame](#)

9. Entry/Exterior Doors Entry/Exterior door hardware acceptable - [Moisture damage at front entry door frame](#)
10. Windows Casement, Wood, Vinyl - [Control is damaged at living room window - Right side](#)
11. Smoke Detector: Located at Bedrooms, Living area, Every level, Responded to test button - [Smoke detector did not respond when tested at upper level hallway](#)
12. C/O Detector: [Recommend C/O detector within 10 feet of sleeping areas, minimum 1 on every level - No C/O detector at lower level](#)

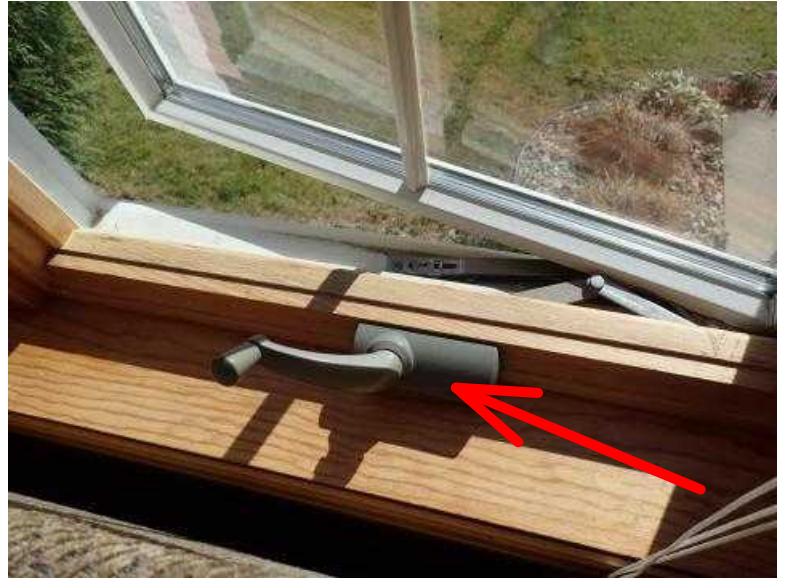
3. Repairs Recommended Windows Casement, Wood, Vinyl - Control is damaged at living room window - Right side

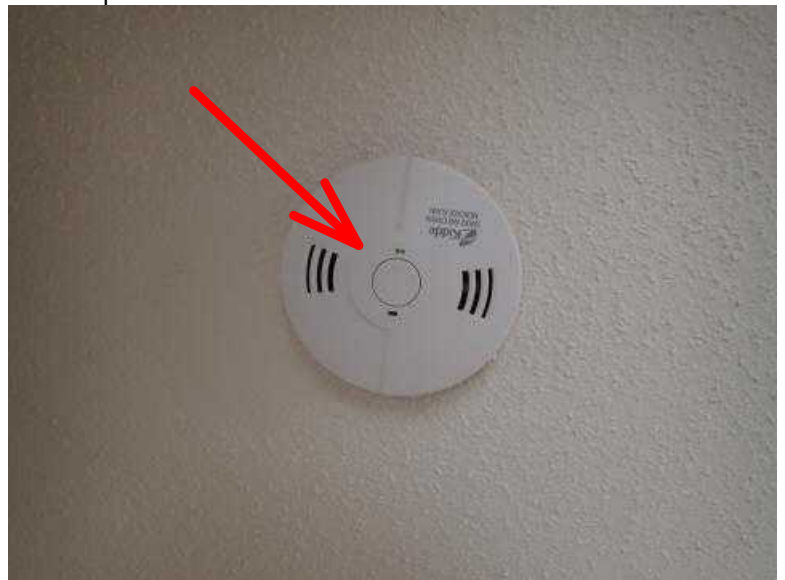
4. Acceptable Interior walls Drywall, Common cracks  
5. Acceptable Ceilings Drywall, Common cracks  
6. Acceptable Floors Carpet, Vinyl, Wood  
7. Acceptable Ceiling Fans  
8. Acceptable Interior stairs Handrail appears acceptable  
9. Repairs Recommended Smoke Detector: Located at Bedrooms, Living area, Every level, Responded to test button - Smoke detector did not respond when tested at upper level hallway

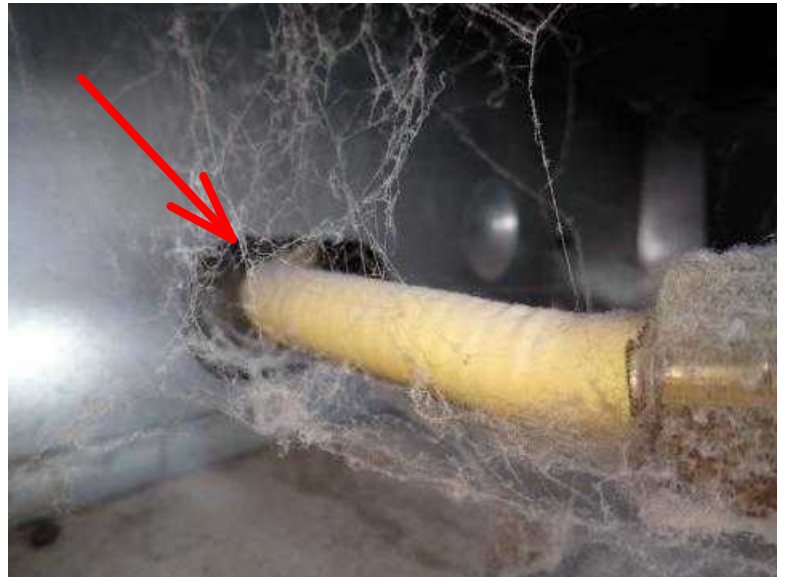
1. Type: Prefabricated gas
2. Acceptable Burn Chamber: Metal
3. Acceptable Vent System: Wall direct vent - Metal
4. Not Present Damper:
5. Acceptable Blower/Fan:
6. Acceptable Doors/Screens
7. Acceptable Hearth: Tile
8. Repairs Recommended Gas Piping/Valve CSST -  
Recommend hard piping through chassis or providing protective sleeve as it passes through chassis

13. Basement Fireplace Gas Piping/Valve CSST - [Recommend hard piping through chassis or providing protective sleeve as it passes through chassis](#)

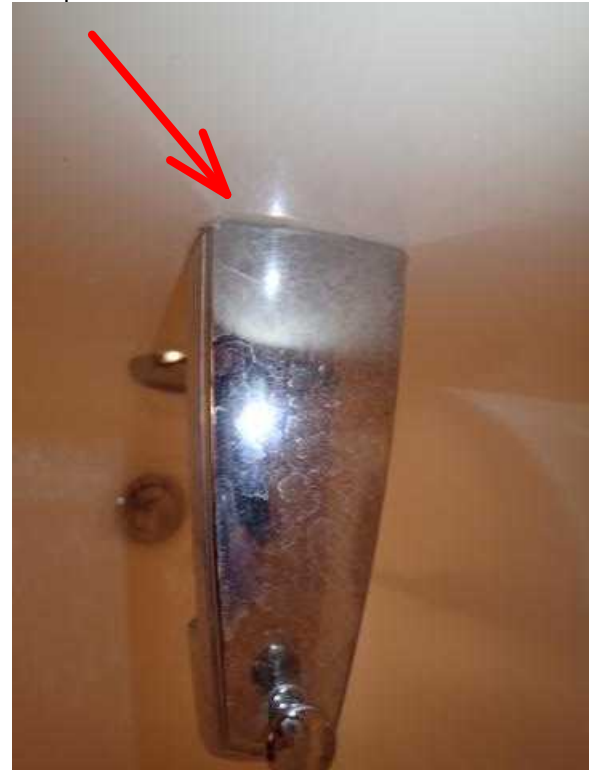
- 1. Acceptable Toilet: Plumbing acceptable
- 2. Acceptable Sink/Cabinet: Faucet, plumbing under sink acceptable
- 3. Maintenance Bathtub: Faucet, drain acceptable -  
[Recommend sealing around tub spout](#)

4. Upper Bathroom Bathtub: Faucet, drain acceptable - [Recommend sealing around tub spout](#)
5. Lower Bathroom Bathtub: Faucet, drain acceptable - [Cracked tiles next to bath tub enclosure](#)

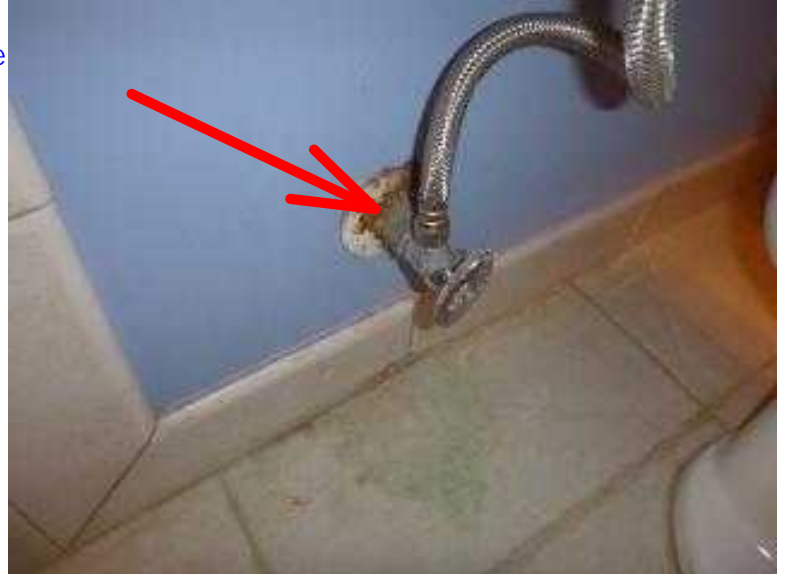
6. Repairs Recommended Toilet: Plumbing acceptable  
- [Leak at water supply valve](#)

14. Master Bathroom Toilet: Plumbing acceptable - [Leak at water supply valve](#)

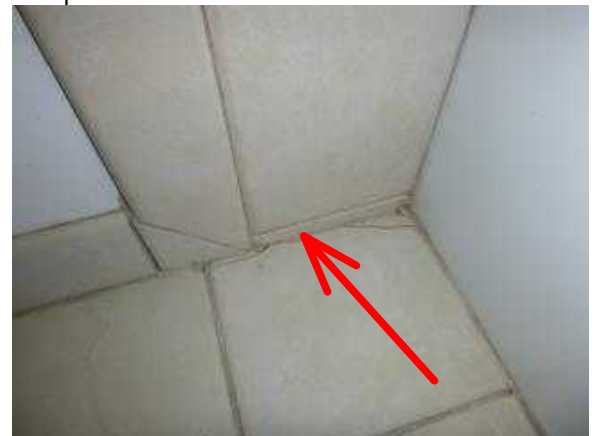
11. Acceptable Toilet: Plumbing acceptable  
12. Acceptable Sink/Cabinet: Faucet, plumbing under sink acceptable  
13. Maintenance Bathtub: Faucet, drain acceptable -  
[Cracked tiles next to bath tub enclosure](#)

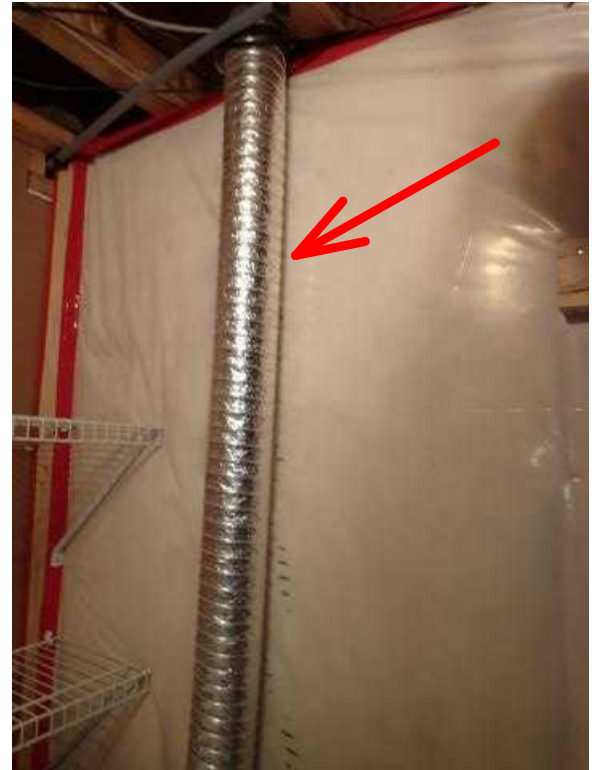
1. Acceptable Washer/Dryer Electrical: 240 volt dryer outlet present
2. Not Present Laundry Tub:
3. Repairs Recommended Dryer Vent: Metal flex - **Recommend solid metal smooth bore dryer vent**

15. Basement Laundry Room/Area Dryer Vent: Metal flex - [Recommend solid metal smooth bore dryer vent](#)

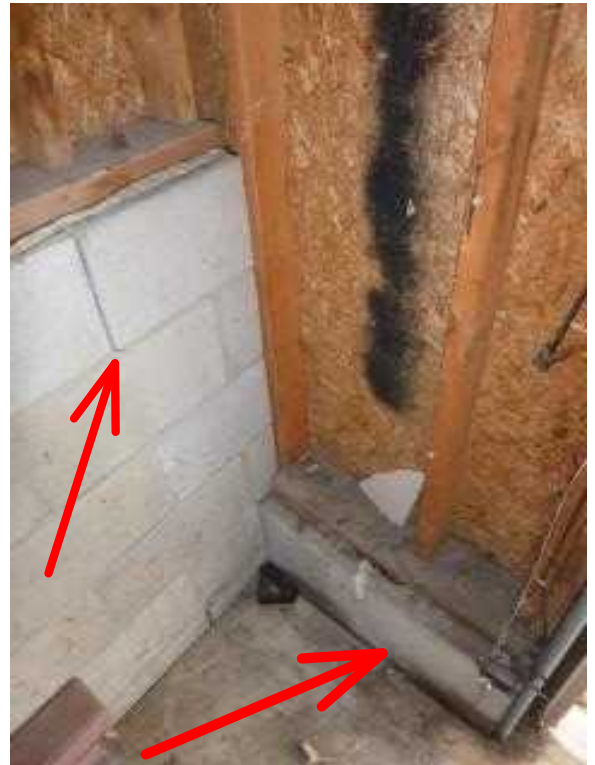
1. Repairs Recommended Floor/Foundation: Concrete, Common cracks - [Displaced block at front garage wall](#)

16. Tuck under, Attached Garage Floor/Foundation: Concrete, Common cracks - [Displaced block at front garage wall](#)
